Restoring a Natural Resource Treasure in Northern Virginia

The Central Wetland Area at Huntley Meadows Park

WETLANDS RESTORATION

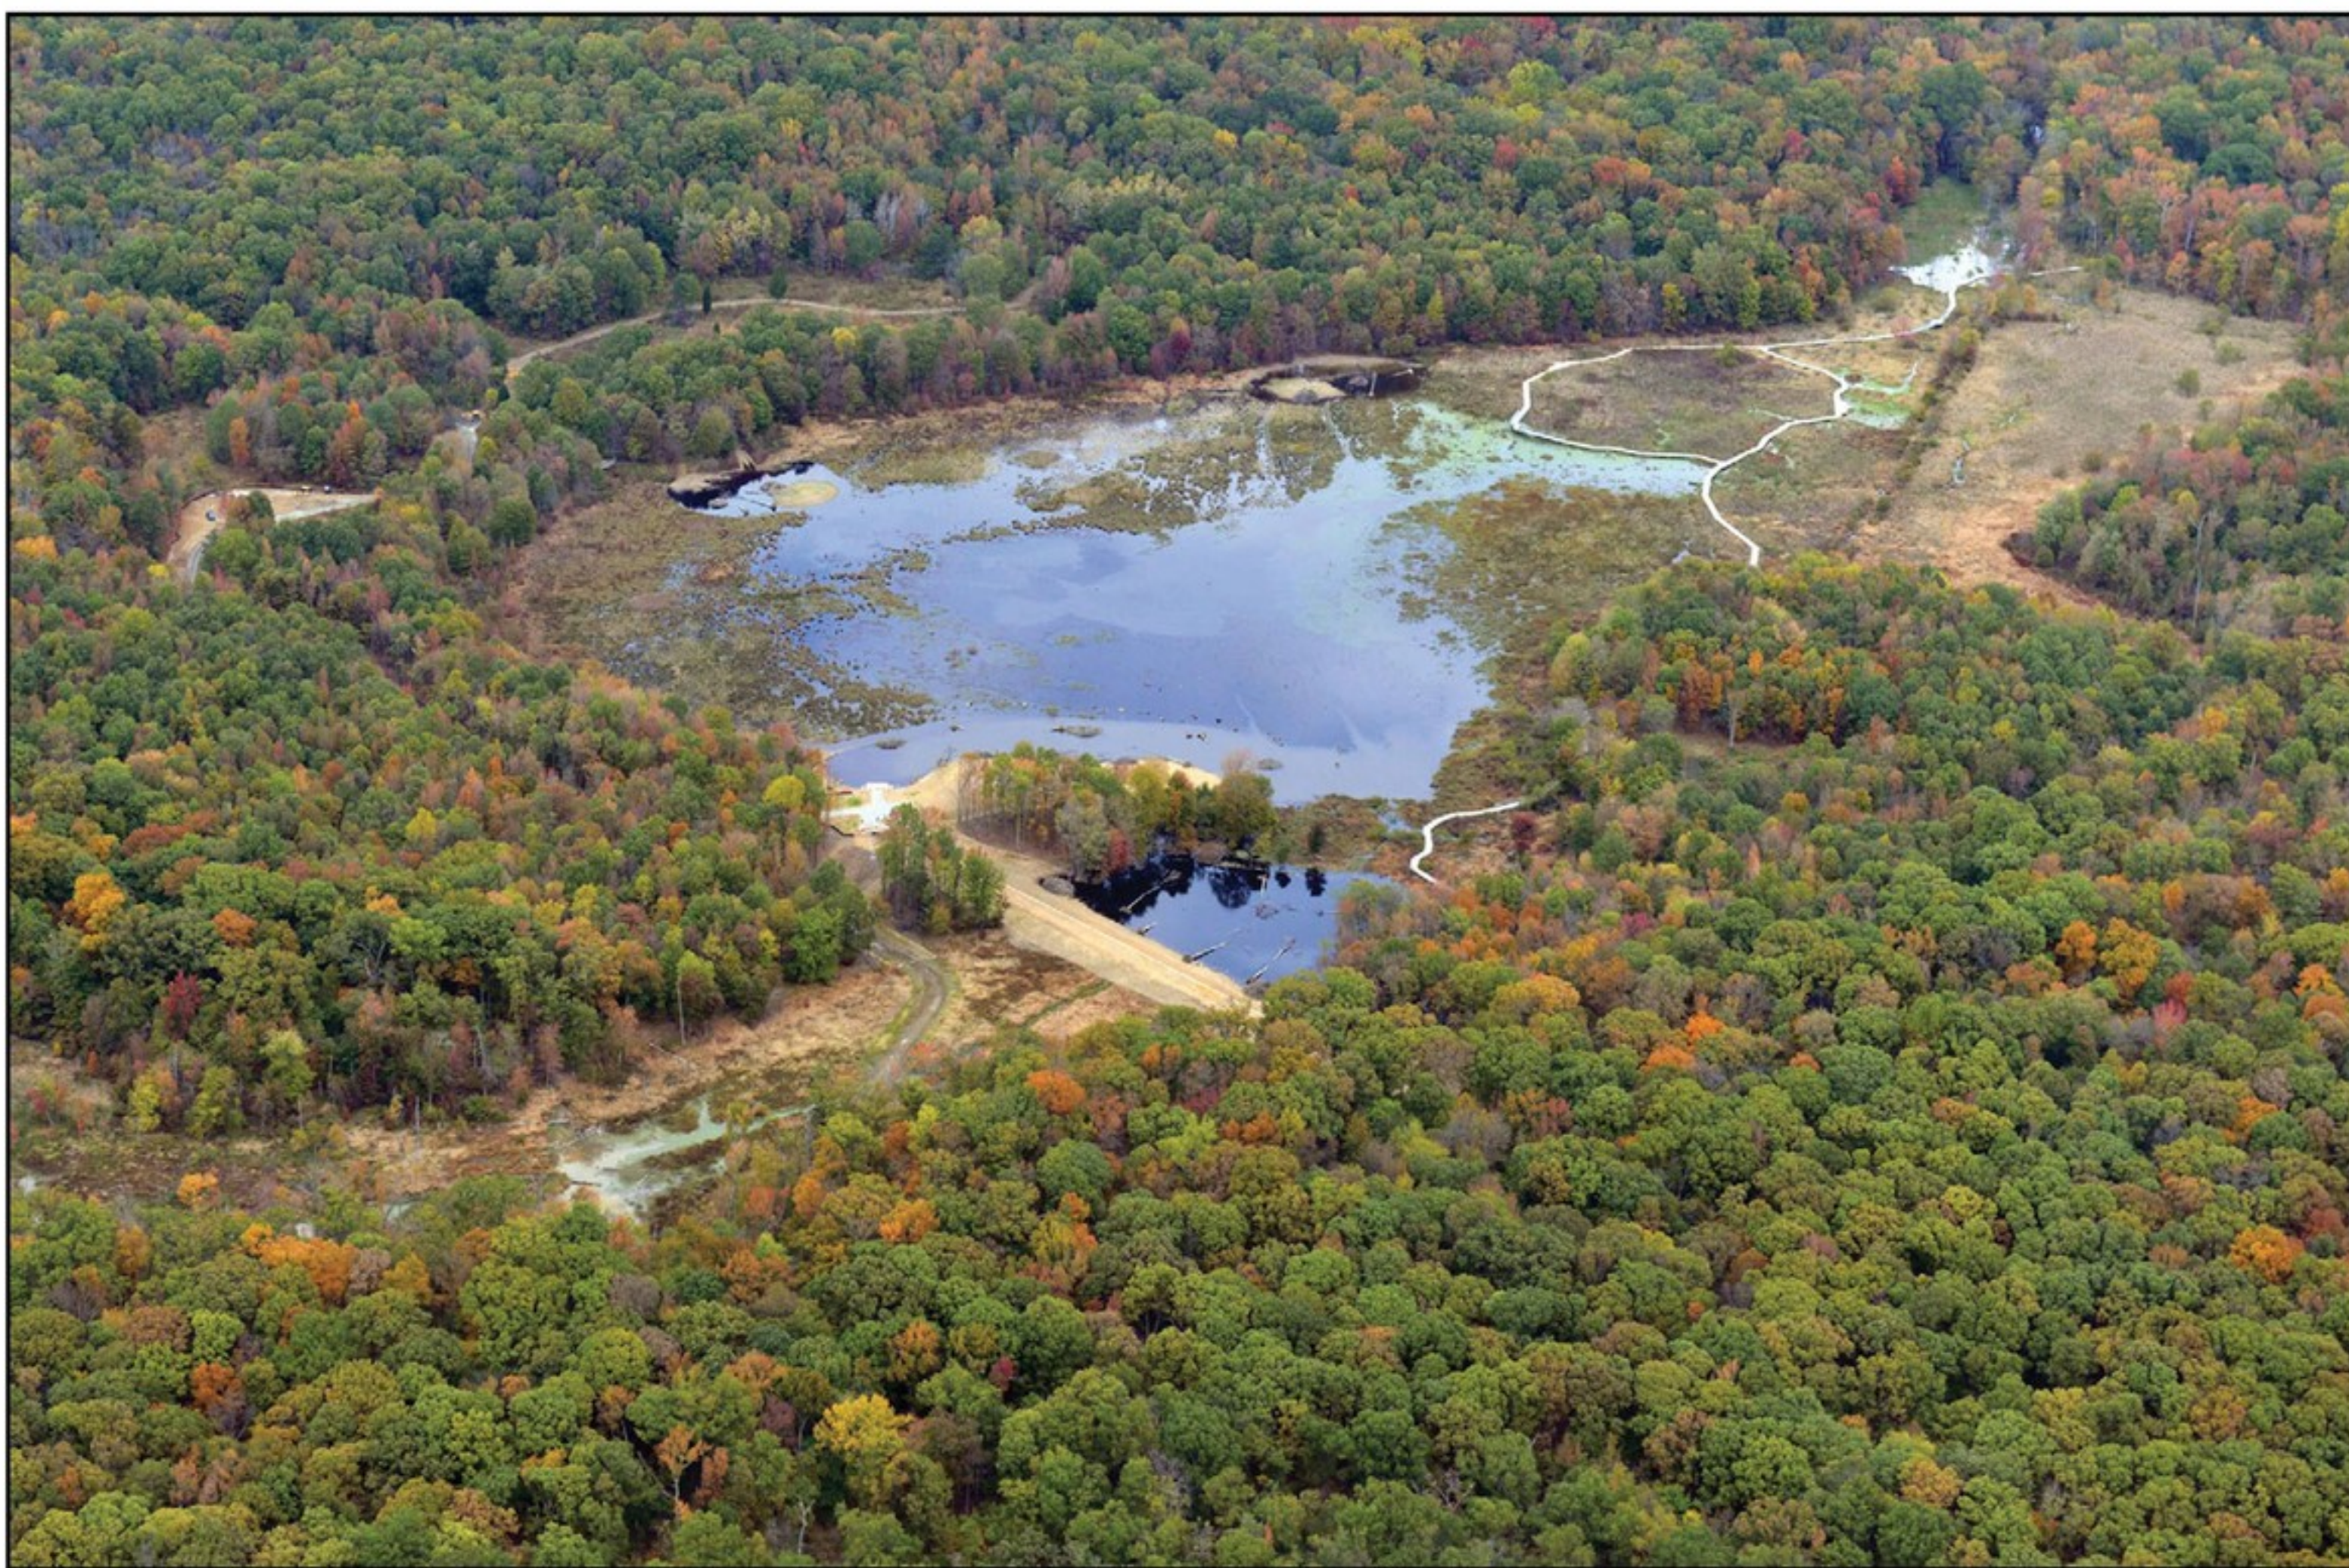
Aerial view of project, October 2013.

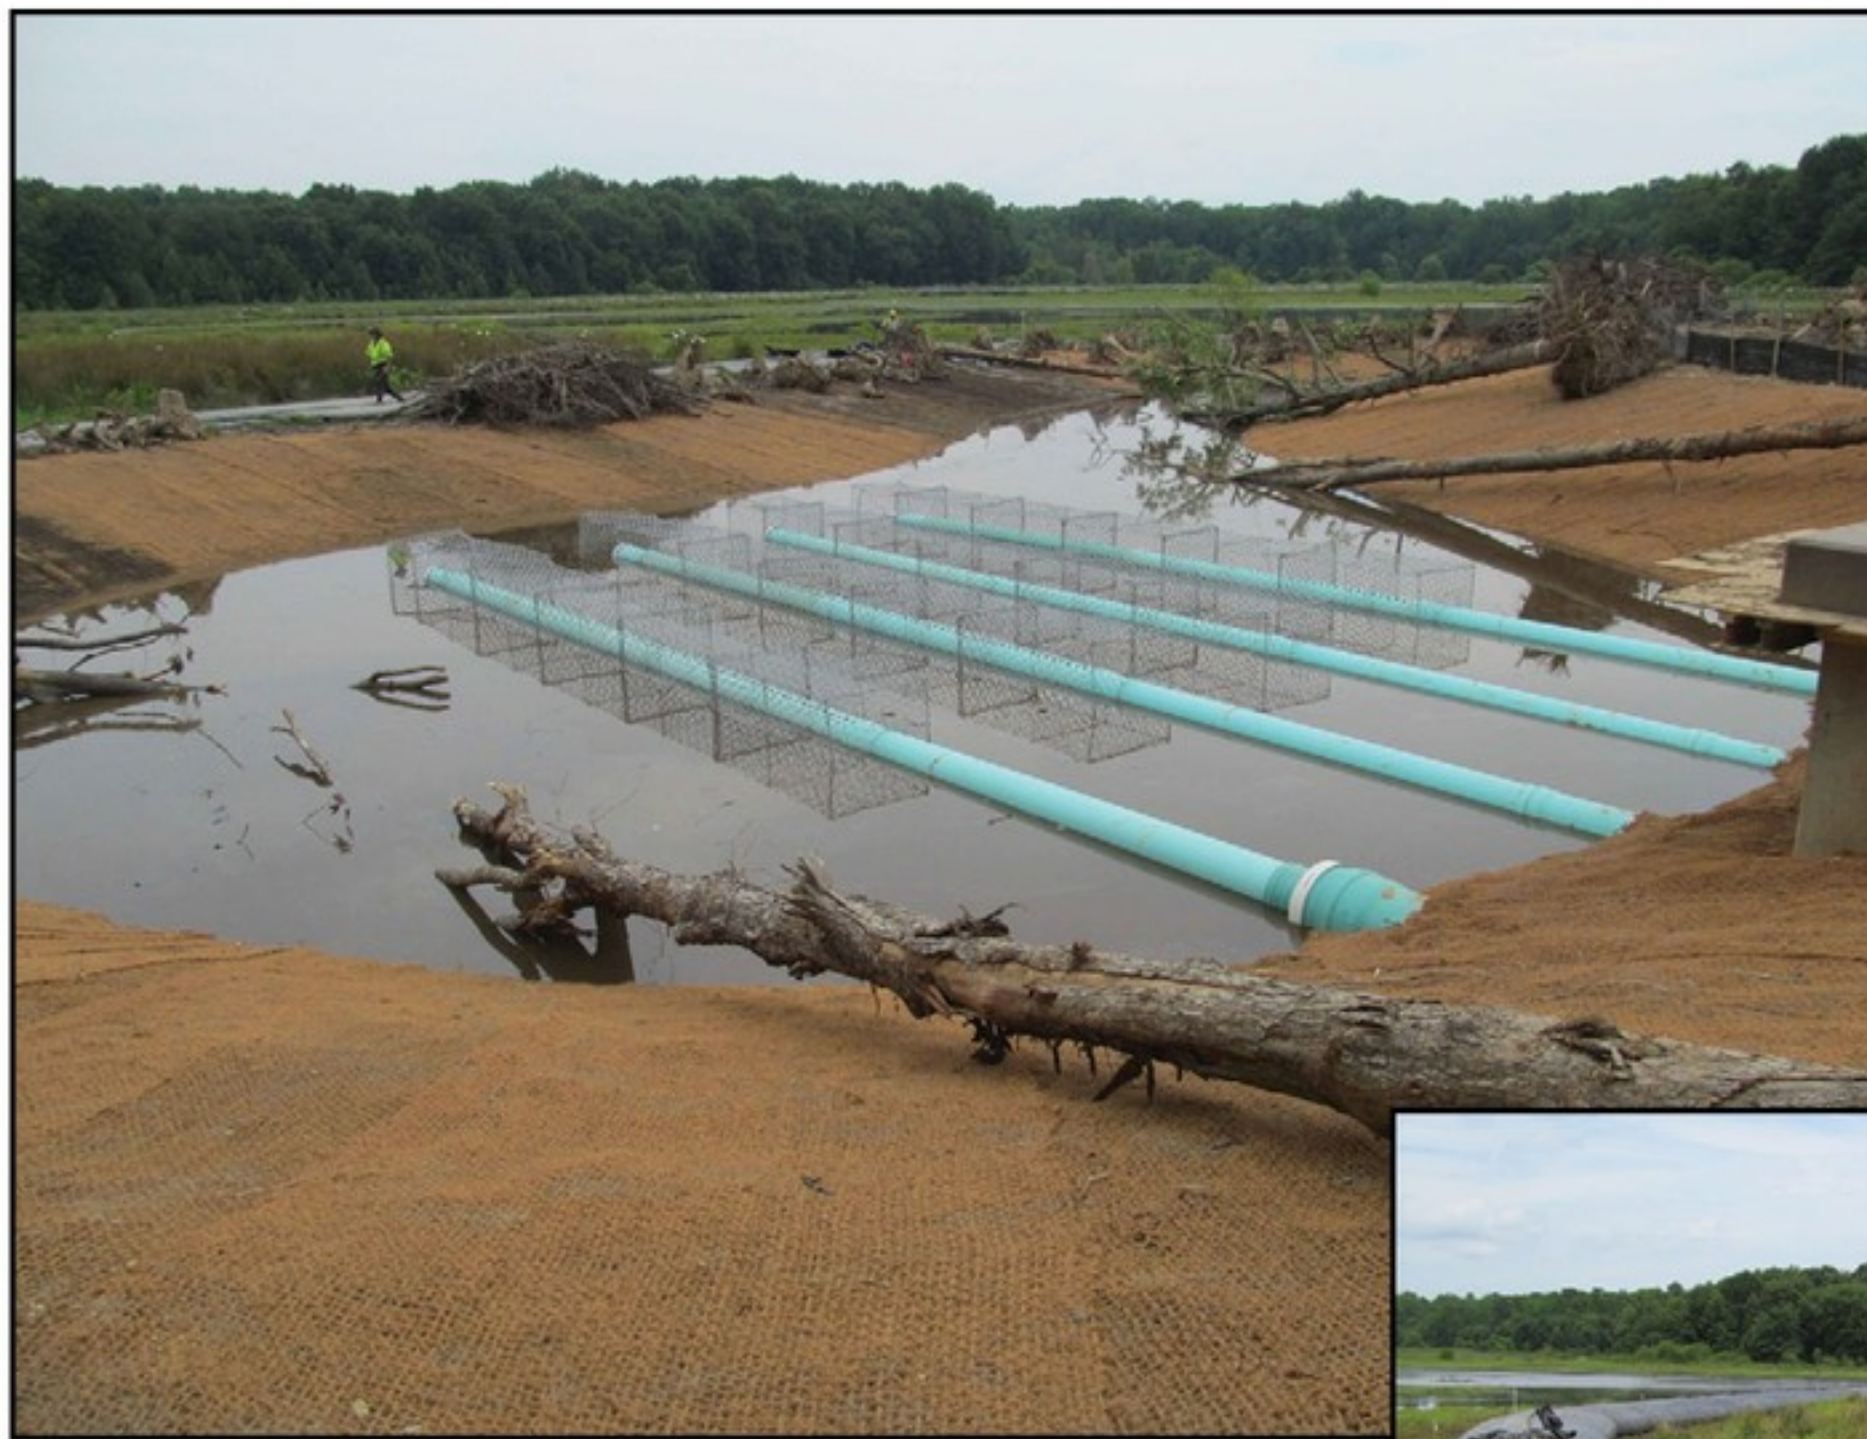
Clemson Water Levelers. Inset: Aqua-Dam in place.

A second innovative technique employed in the project was the use of Clemson Beaver Pond Levelers, installed in deep habitat pool (habitat pool "A" located immediately adjacent to the concrete outlet structure). This device allows baseflow to discharge through submerged pipes, thereby eliminating the noise from surface flows that would attract beavers. This technique will allow the continued habitation of beavers with minimal impacts to the outlet

Phase II included excavating the side discharge outfall channel and the largest habitat pool (Pool A). Pool A is the deepest of the four habitat pools and was excavated to the lowest elevation in the wetland to ensure sufficient drawdown could be achieved when the gates were lowered. An Aqua Dam (comprised of a hollow tube about 6 feet in diameter that is filled with water) was installed around the area which would ultimately be Pool A to enable it to be excavated “in the dry”. All excavated top soil and clay was stockpiled. The clay was used as an impermeable core in the access road (as it also serves as a berm to contain very high water levels). After the excavation of Pool A was completed, the

Clemson Water Levelers were installed. When complete (end of July), water was diverted through the outlet structure and side outfall channel to ready the construction of the water control berm. (Phase III).

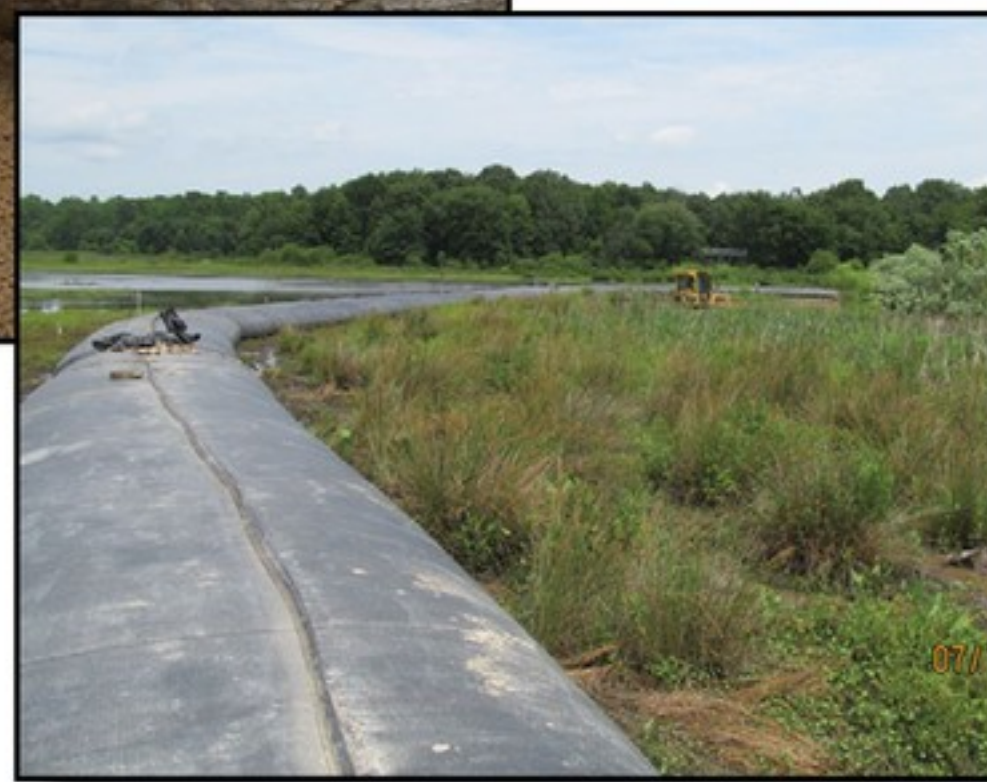
structure from damming activities.

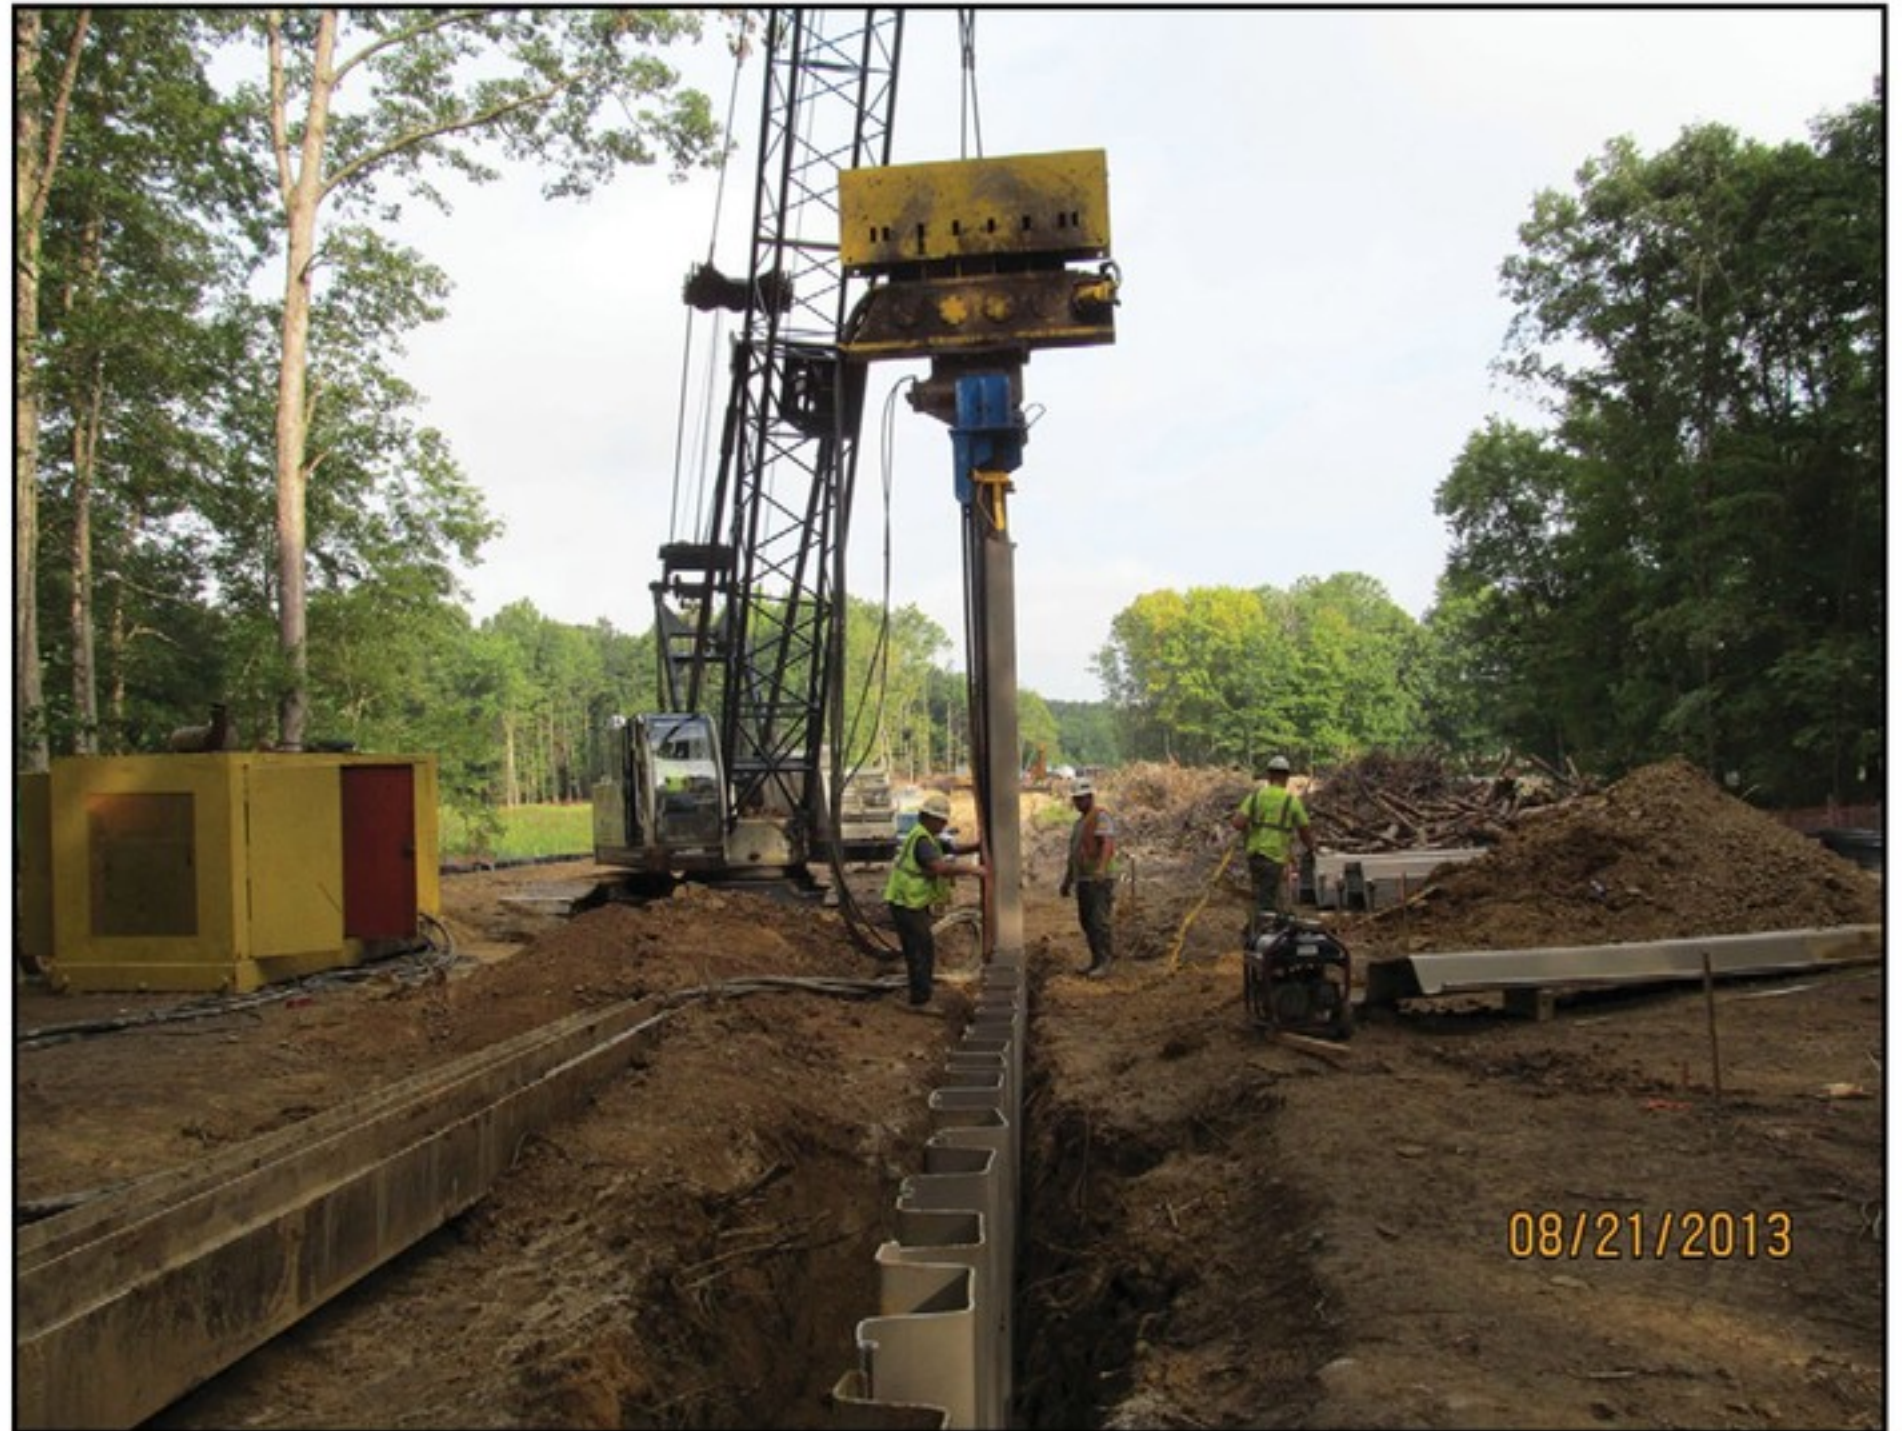
Sheet pile installation of water control berm.

The installation of the vinyl sheet piling used as the impermeable core of the water control structure berm was performed by McGee Mobile Crane Inc. Installation was performed using a crane with a hydraulic, vibratory hammer. Due to the sensitive nature of the site, vegetable oil was used instead of hydraulic fluid in case a leak or rupture occurred in the lines during construction. The sheet piles were driven 20 ft into the ground to ensure no water would

leak or discharge out of the wetland under the sheet piling due to the alluvial nature of the soils under the 5-10 ft deep layer of clay on which the wetland was perched. A rocky bed mix of Class IA rip-rap, cobble, sand and topsoil was used behind the sheet piling to provide additional support as well as erosion control during flooding events that over-top the berm while allowing vegetation to grow on the substrate. Once all the sheet piling was installed to the proper depth it was cut off at the desired elevation of 34.5 ft above sea level. The construction portion of Phase III was completed in November 2013.

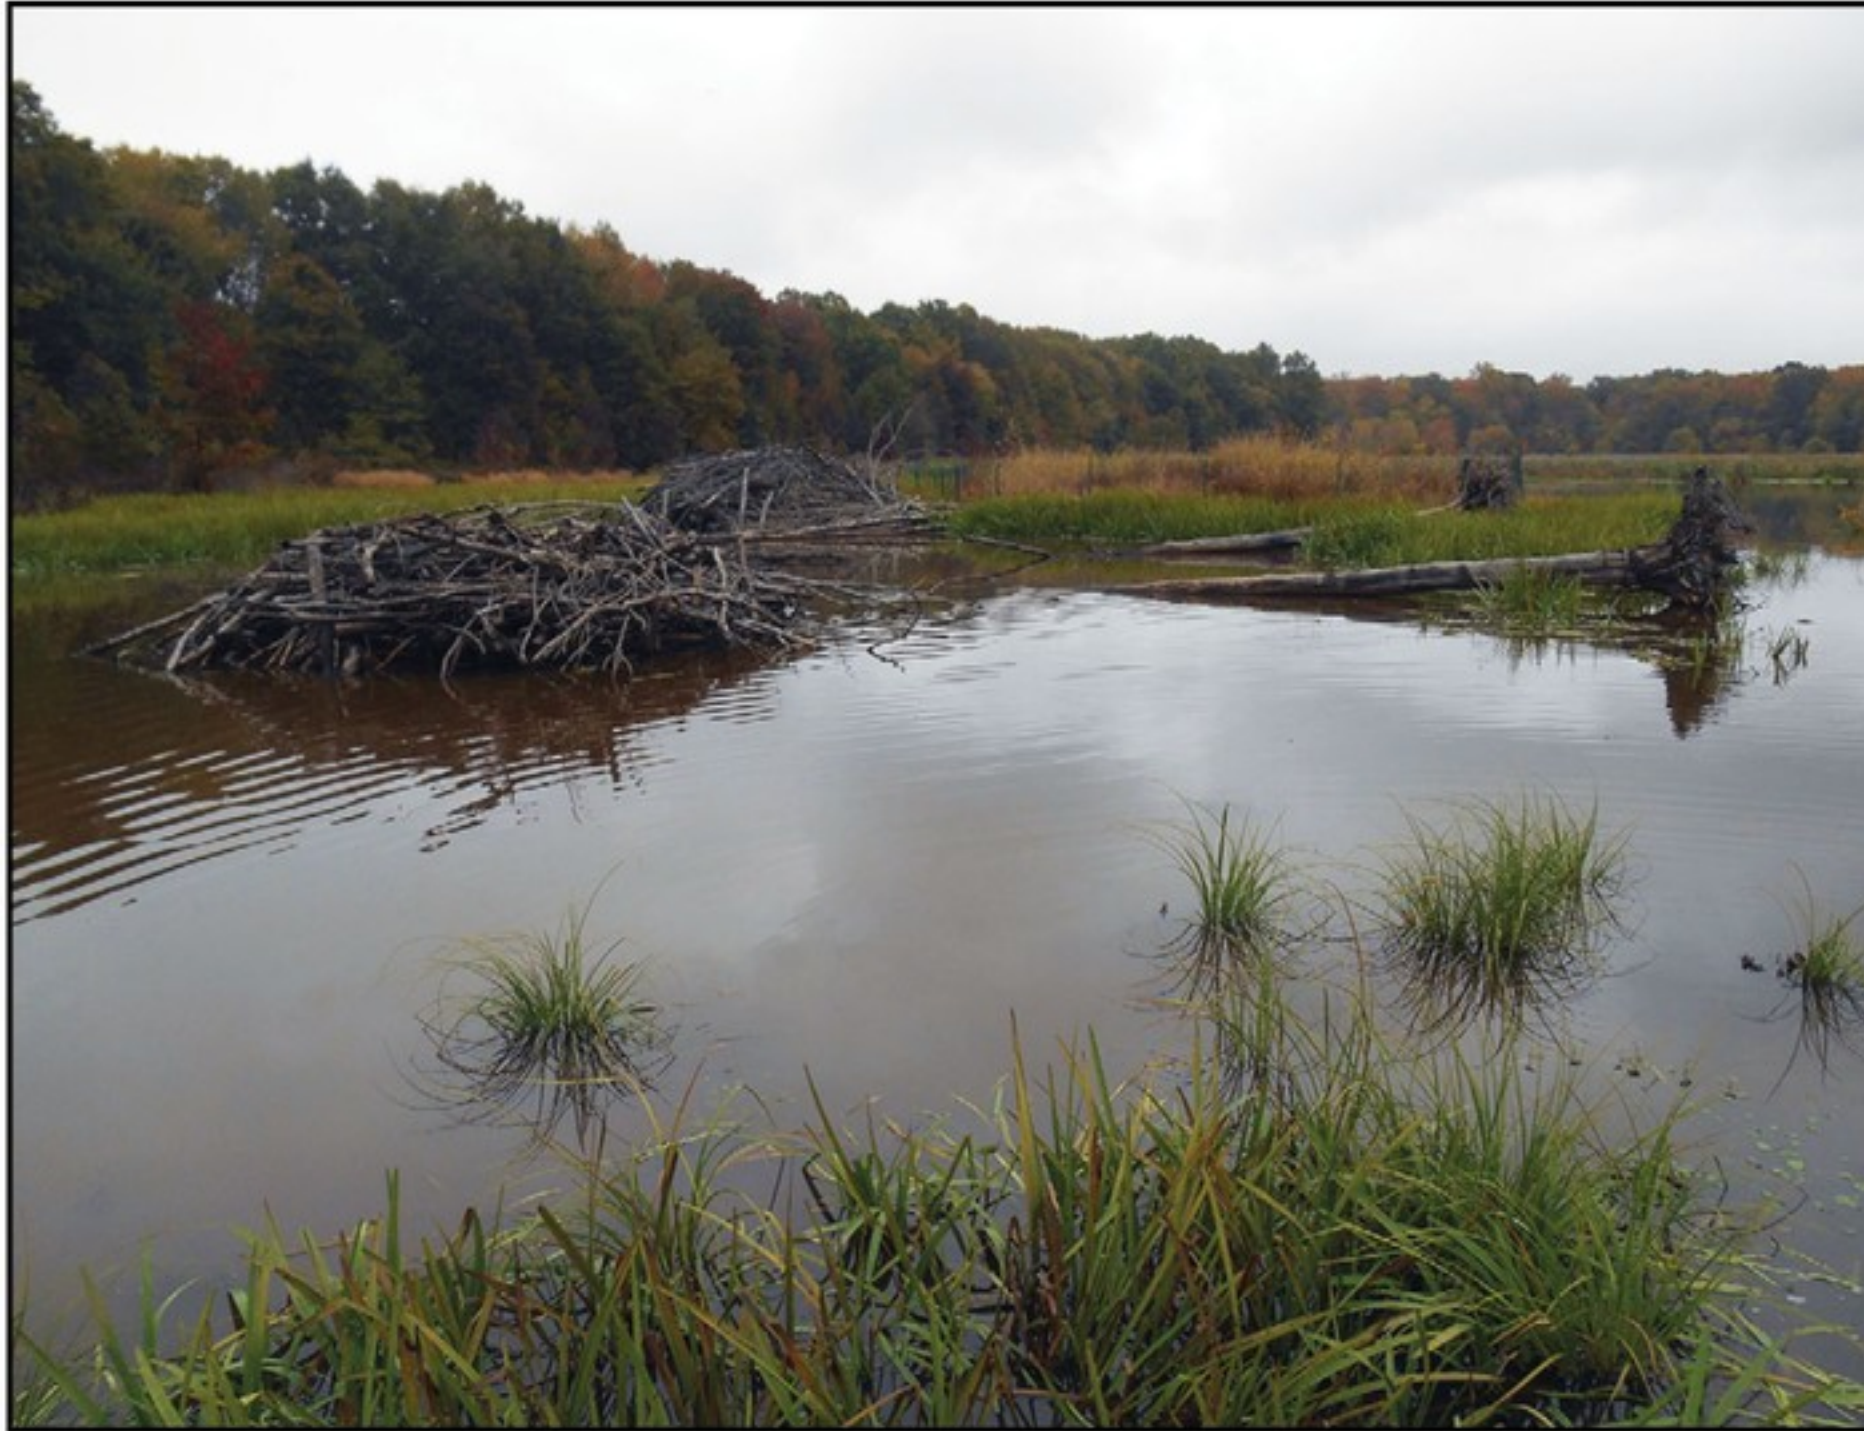
Habitat Pool B - post construction.

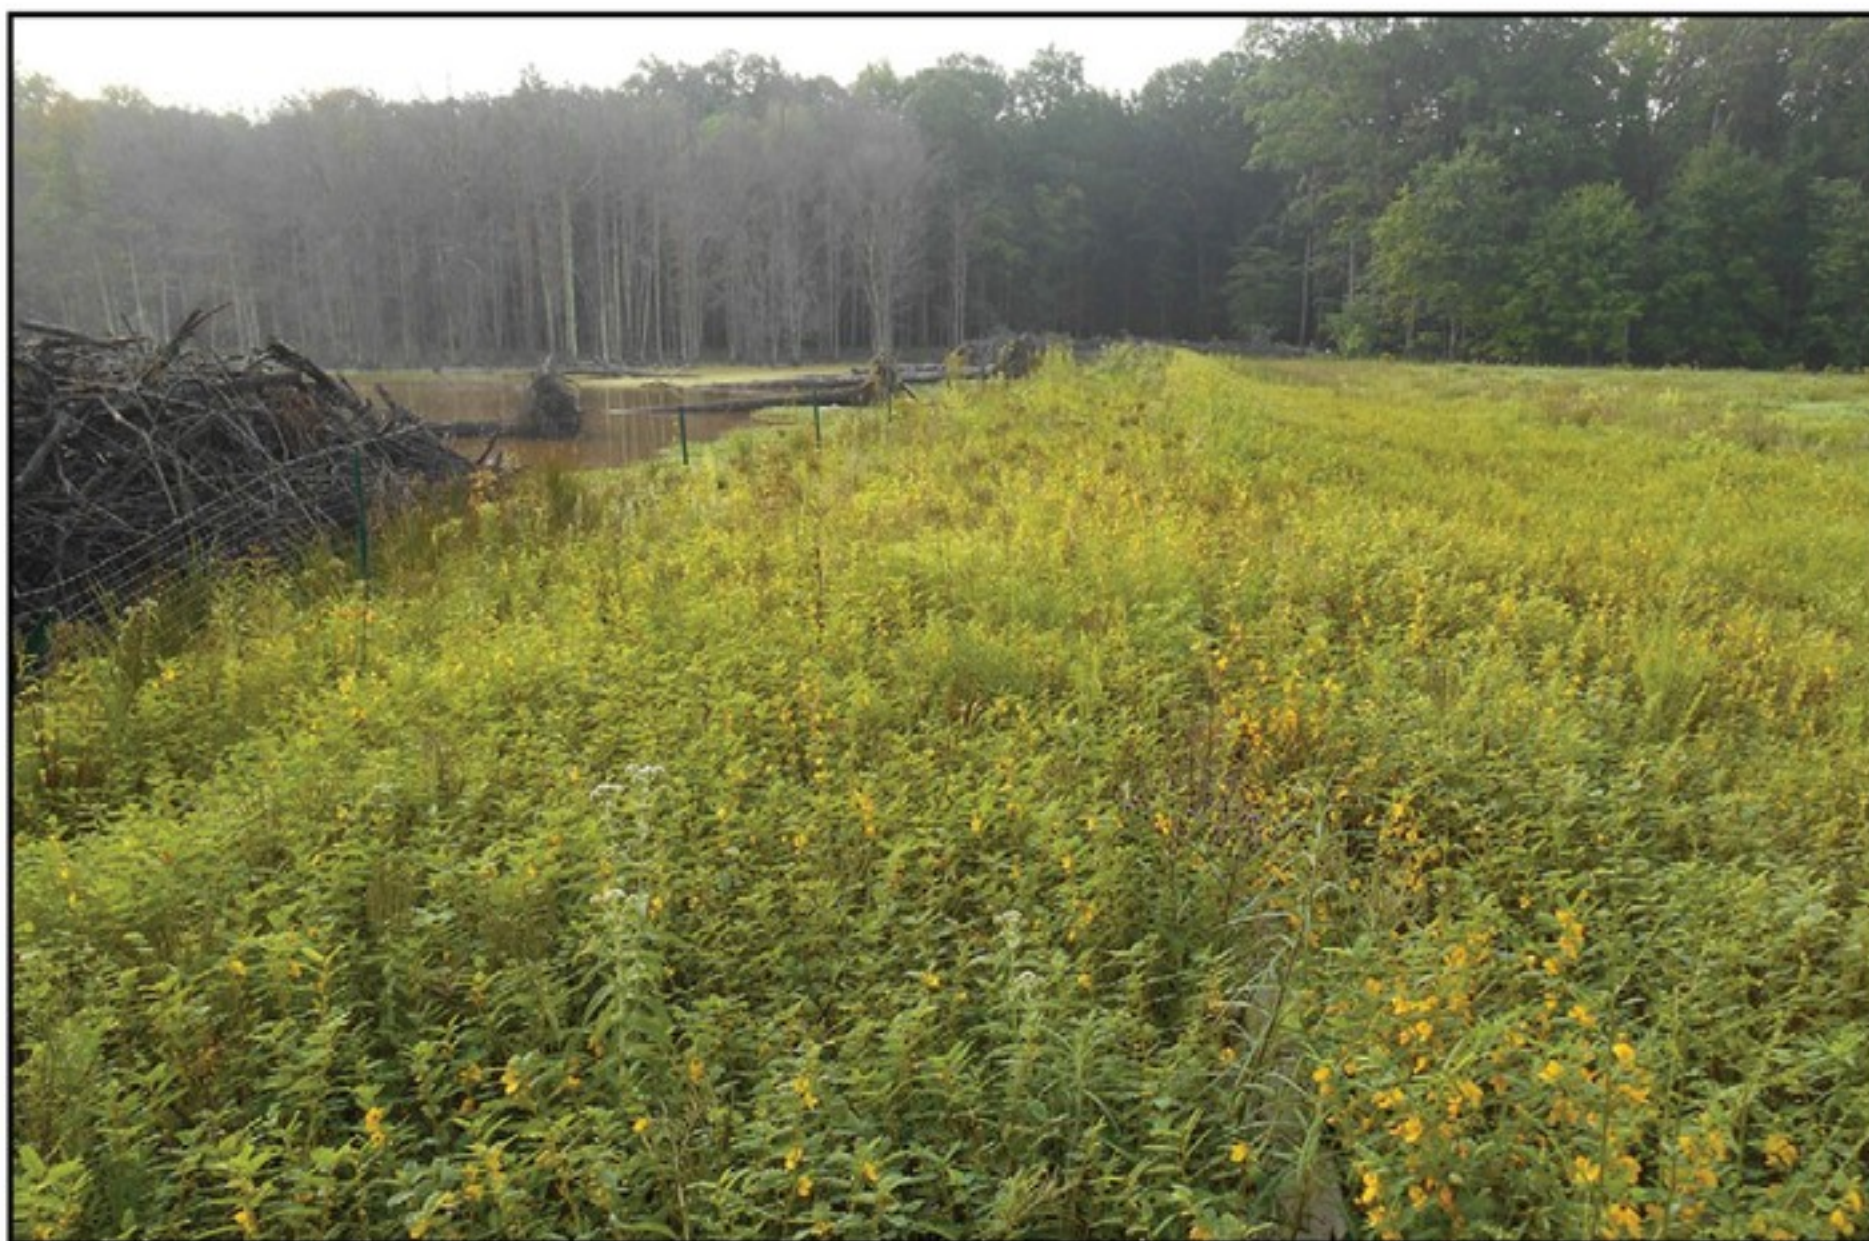
Berm in 2015.
